ANNUAL REPORT FOR 2002

Pembroke Creek Mitigation Site
Chowan County
Project No. 8.T010602
TIP No. R-2512

Prepared By:
The Office of Natural Environment & Roadside Environmental Unit
North Carolina Department of Transportation
December 2002

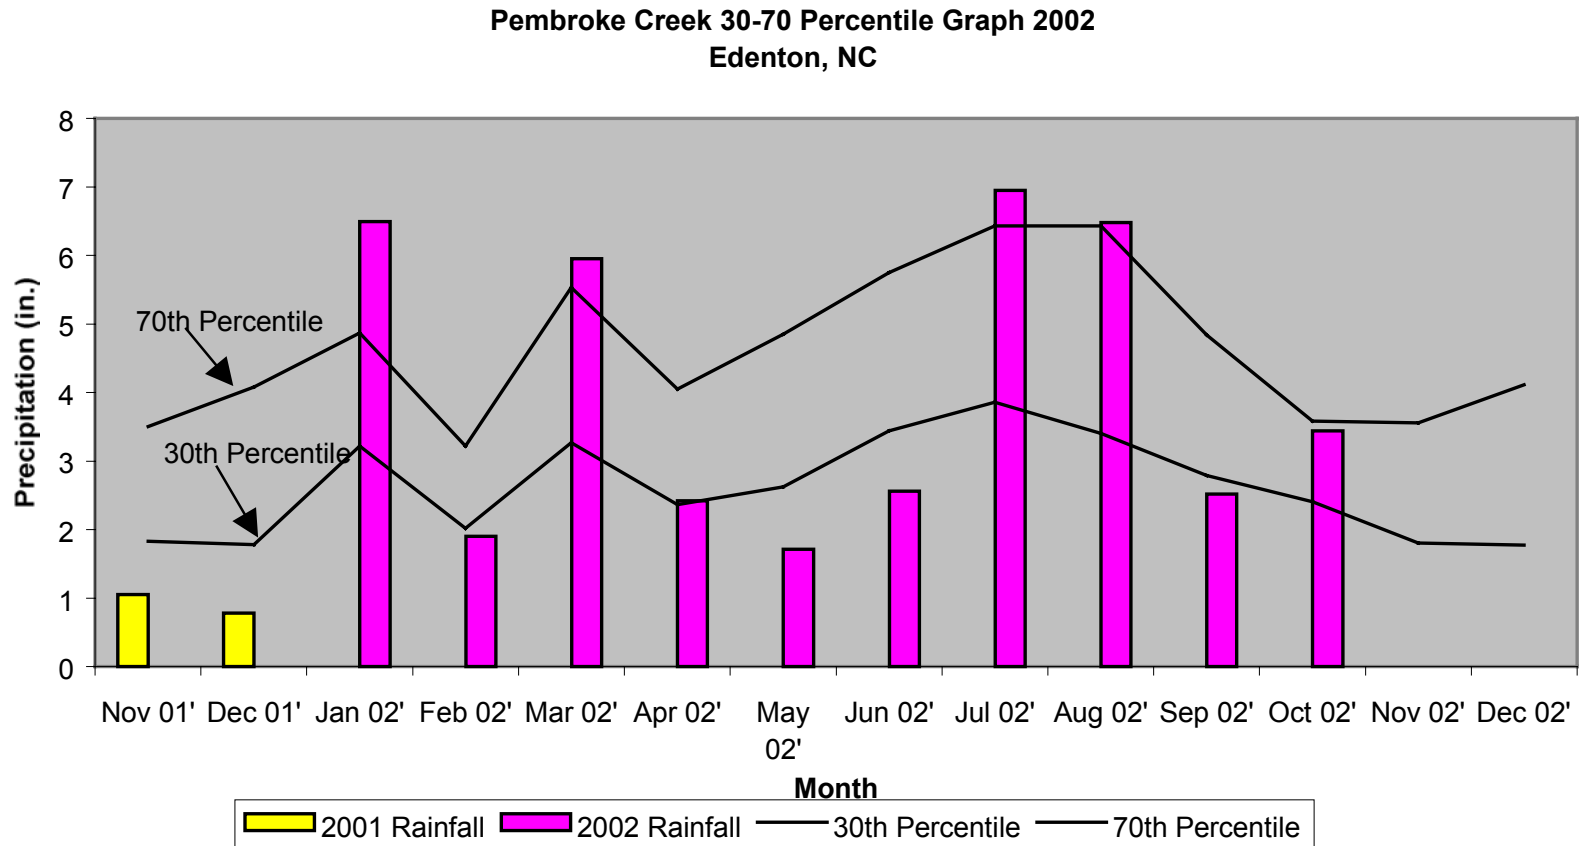
Figure 4. Historical Rainfall Data (30-70 Graph)

Figure 4 is a comparison of 2002 monthly rainfall to historical precipitation for the Edenton area. Rainfall data recorded onsite during the growing season was compared to the historical 30-70 percentile trends for the area. It is assumed that if the 2002 rainfall totals, represented by bars, fall between the average precipitation values for each month, then the local climate was experiencing average conditions for that particular region.

As indicated by Figure 4, the months of January, March, July and August received above average rainfall. However, every other month except for October saw less than average rainfall. Thus the site was saturated during below average climate conditions.
